Safeguarding the Lesser White-fronted Goose

**Habitat restoration for the Lesser White-fronted
Goose in the Hortobágy National Park, Hungary**

Final Action Report

Hortobágy National Park Directorate

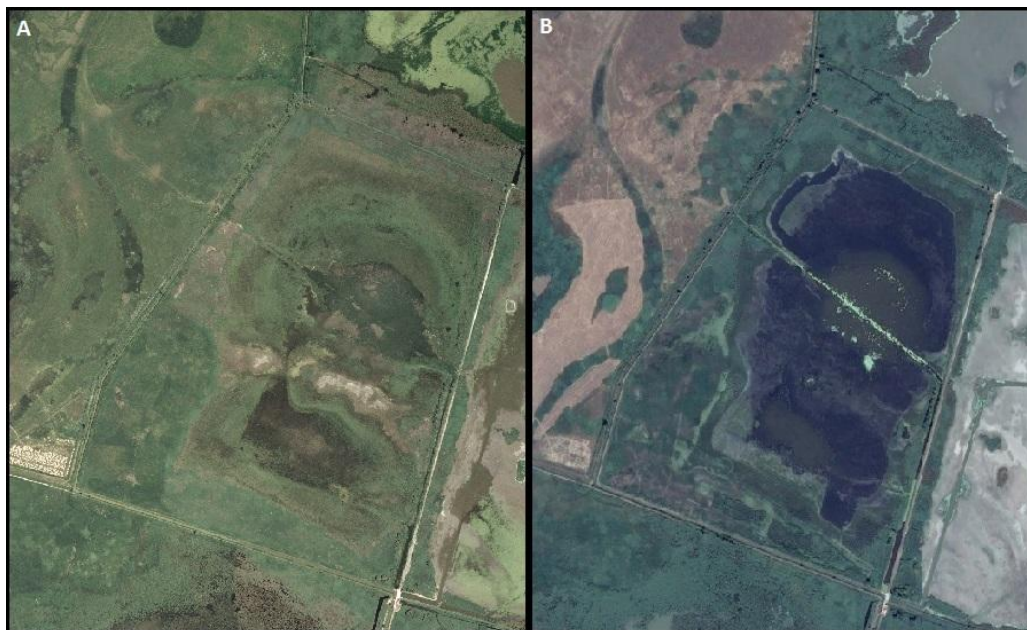
Figure 1. Aerial photographs of the Hortobágy-fishpond no. V., where A refers the year 2005, while B refers the year 2013, after the vegetation management works were done. (fomi.hu/maps.google.com both accessed on 25/04/2017)

The habitat use of the Fennoscandian Lesser White-fronted Goose (*Anser erythropus*), hereafter LWfG population in the Hortobágy National Park concentrates to these fishponds, their adjacent grasslands and marshlands since the mid 1990's (Lengyel et al. 2009, Bogyó et al. 2014). Former observations show that the LWfG mainly use the Hortobágy-fishponds V, VI and Kondás-fishpond. In the recent years, overgrown vegetation (mainly common reed (*Phragmites australis*) and bulrush (*Typha sp.*)) resulted habitat degradation, mainly in Fishpond V. The open water surface of this fishpond almost disappeared by the 2000's and was targeted by the habitat restoration works summarized in this paper (Figure 1.).

The most significant change in habitat conditions is considered the management of Fishpond V (124.6 ha). Before the vegetation and water management, only 15-20 ha of open water surface remained within the lakebed. The dense reed and bulrush vegetation, covering this lake was not suitable for any migrating waterbird including geese species. Following the winter of 2012/2013 a growing open water surface was made available, measuring as around 70 ha recently (Figure 9.). The changes resulted in a rising trend in the numbers of migrating and nesting waterbirds. First Eurasian Coots (*Fulica atra*), *Anas* and *Aythya* species started to use the new open water surface. The first flocks of geese were observed in 2013, mainly GWfG (flocks over 300 individuals) and Greylag Geese (*Anser anser*) (flocks over 350 individuals with juveniles). The first LWfG – a single adult individual - in the Fishpond V

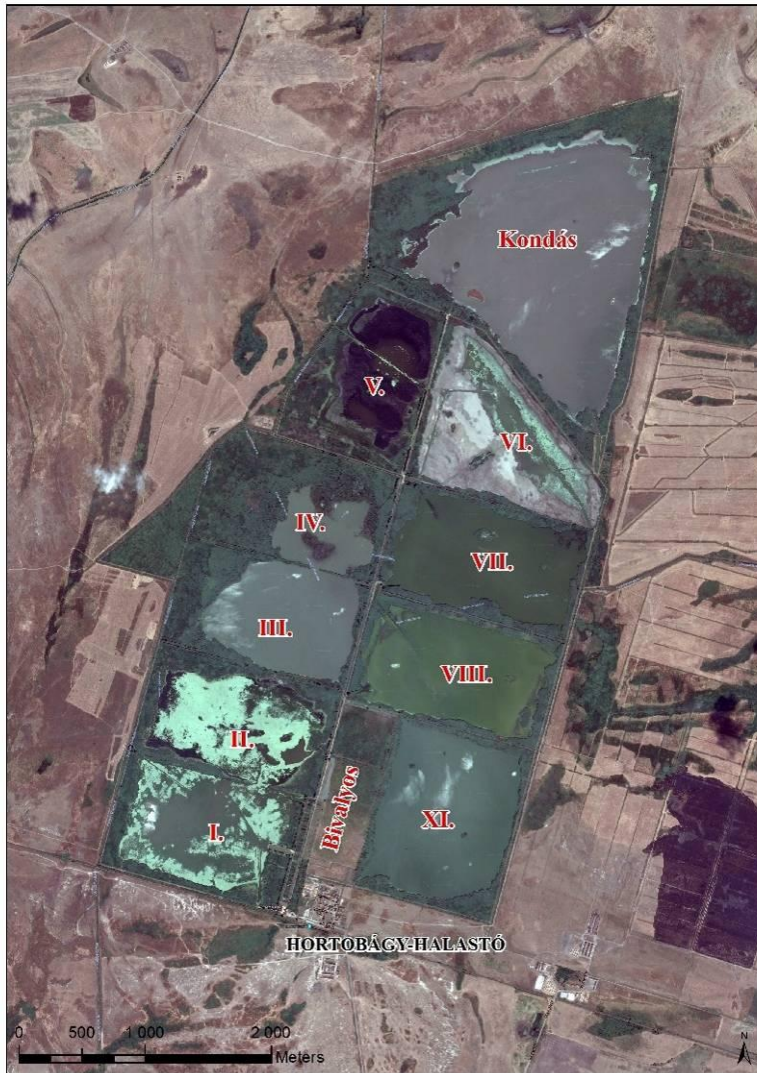
Figure 2. General map of the Hortobágy-fishponds. (fomi.hu accessed on 25/04/2017/HNPD)

Appropriate water management begun in autumn 2011 in the Kondás-fishpond and Fishpond VI (Figure 2.), while following vegetation management actions (Autumn of 2012) suitable water management in the Fishpond V also took place.

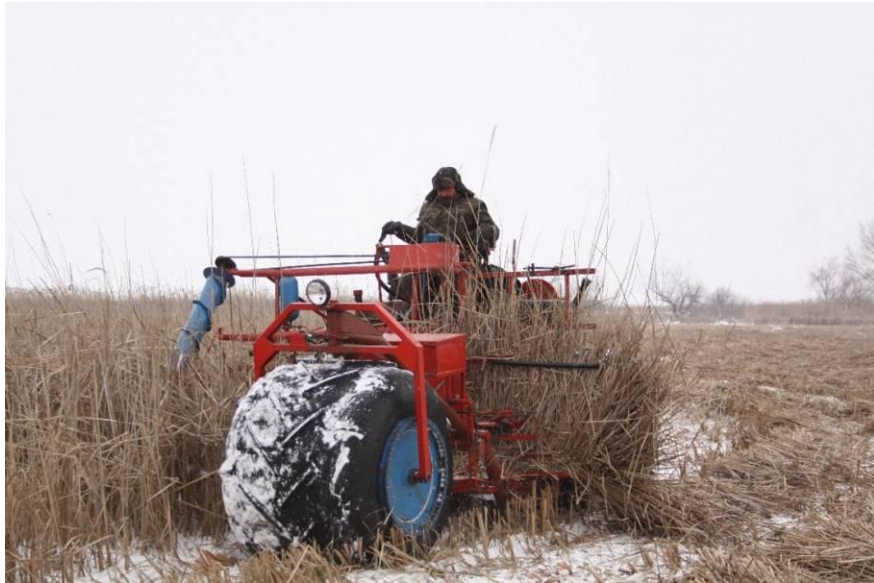
Figure 3. Vegetation management in the Hortobágy-fishpond no. V. using a „Seiga harvester” © János Tar/HNPD archives, February 2012

During the extreme cold (sometimes -15°C or even lower temperatures) winter of 2012, 40 ha of reed and bulrush were cut on the frozen surface of the Fishpond V, by Bob Nád Ltd. (Figure 3.)

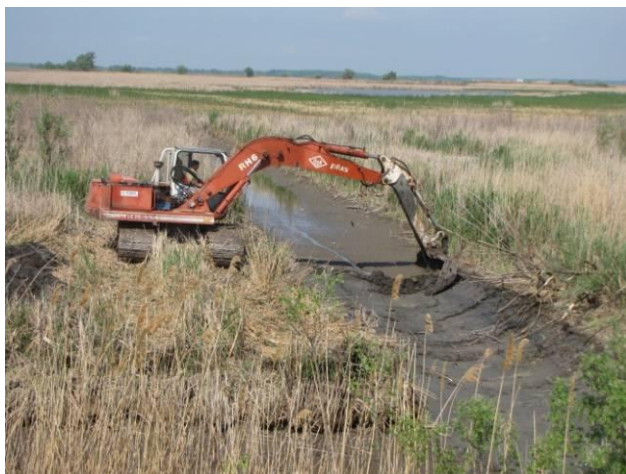
Figure 4. Channel excavation. © Dávid Bogyó/HNPD archives, May 2012

According to the initial management plan, the pond would be subsequently drained in order to provide machinery access for vegetation management. However, dense vegetation prohibited water drainage and as a result a 200 m drainage channel was restored by Skarabeus Ltd., using an excavator in order to allow drainage of the pond (April 2012), (Figure 4.).

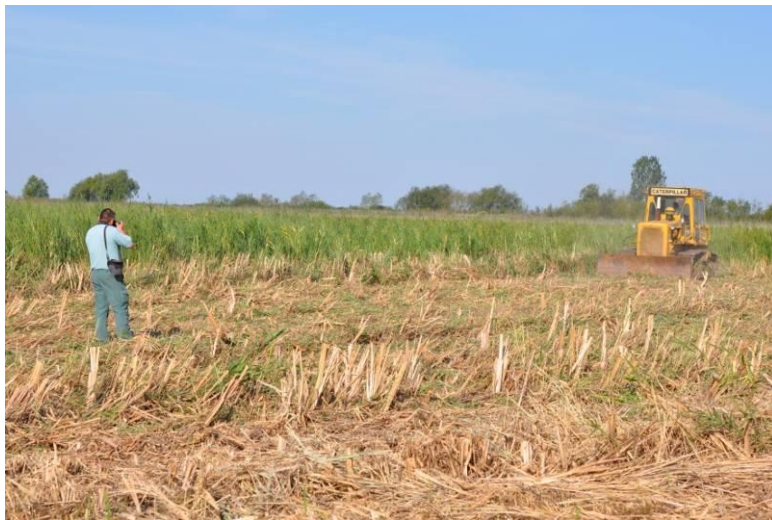
Figure 5. Cutting and trampling reed and bulrush with a caterpillar in the dry lakebed of the in the Hortobágy-fishpond no. V. © Dávid Bogyó/HNPD archives, August 2012

Because of this reason, later in August we contracted with a new external assistant (Pumkin Ltd.; Figure 5.) with two caterpillars who was able to do the remaining job until the 26th of August (trampling the old reed and bulrush down). With this method we managed ca. 45 ha. Summarizing the total managed (through cutting and trampling in the winter and summer periods listed above) vegetation (mainly overlapping areas) ranks up to 50ha.

Fishpond V was immediately flooded and filled to its maximum level in order to prevent any vegetation from re-emerging, since reed and bulrush in particular are not able to survive flooding. For reed and bulrush respectively, water level should be 20-30 cm higher than the remaining vegetation. The winter conditions that followed resulted in the freezing of Fishpond V, which further contributed to reed and bulrush destruction through destruction by ice sheets.

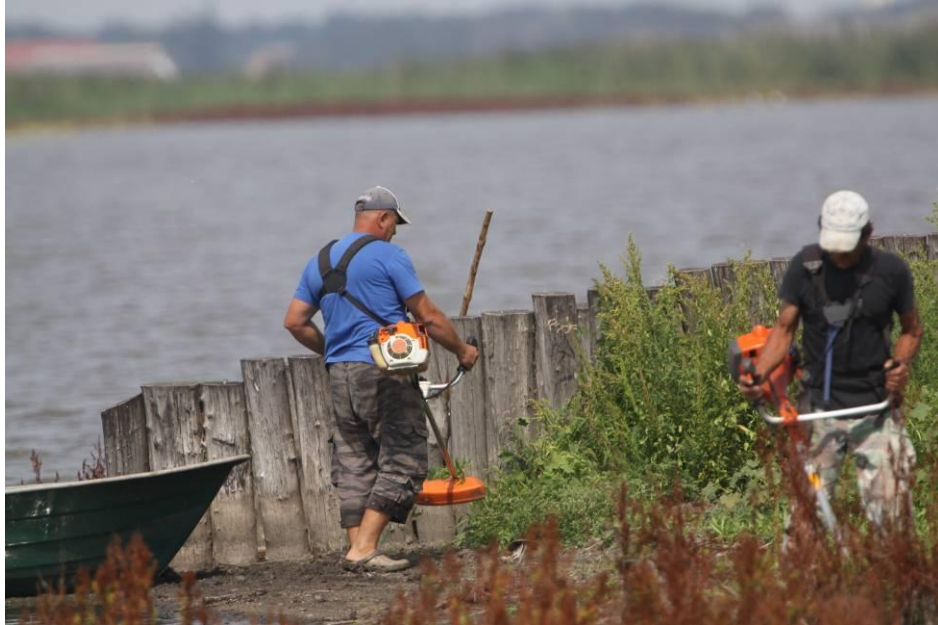
Figure 6. Habitat management on the Kondás island . V. © János Tar/HNPD archives, August 2014

Continued vegetation cutting after the breeding period was complete and an additional 2 ha of vegetation was removed from the Kondás island surface in 2014 and in 2016 by self-employed Takács János (Figure 6.) in order to provide a safe (from predators) and ideal (fresh mud-vegetation) staging site for the LWfG.

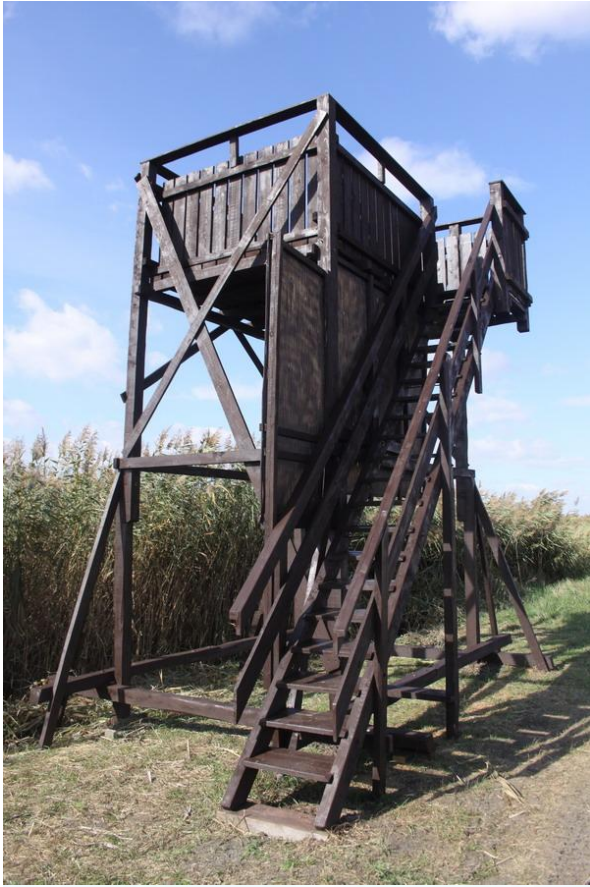
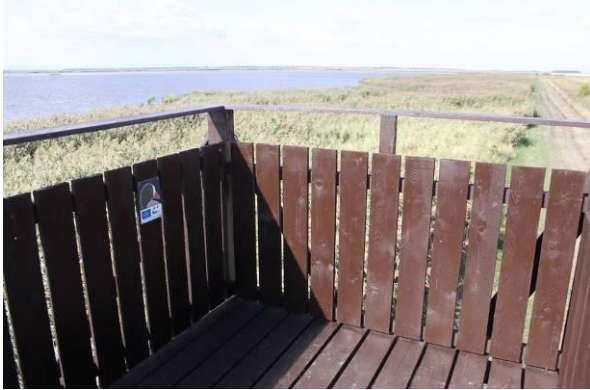
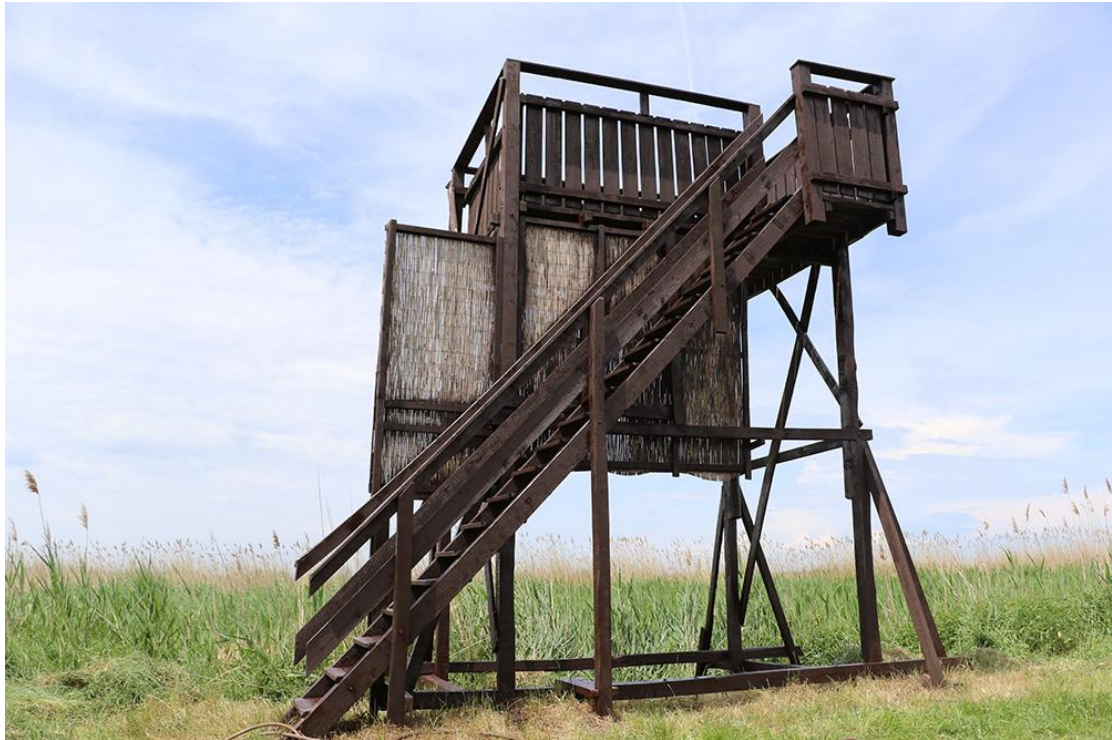
Figure 7. The newly re-built (2013) and re-painted (2017) hide at lake Kondás . © János Tar/HNPD archives, March 2017

Also in the framework of the LWfG LIFE+ project, HNPD built a hide on the shore of the Kondás fishpond by Gém és Társai LP. The Kondás lake itself is a huge lake (401.4 ha). Observation towers/hides are situated on the southern shores. On the eastern shore there was also one but during the years it was destroyed by wildfire events and wind. It was necessary to build one here again to get a better look on the geese flocks when they use the eastern and northern part of the lake. From other towers/hides these parts are very badly visible due to big distances.

In March 2017, the hide was re-painted to preserve its condition against harsh weather circumstances (Figure 7.)

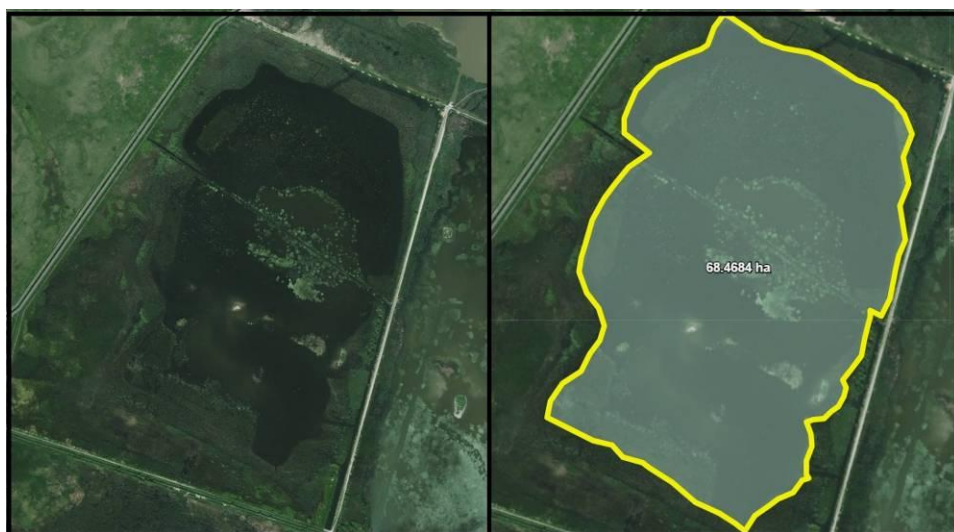
Figure 9. The open water surface on Fishpond V, according to the portals own area measure tool, on the latest aerial photo (2015), on the Portal of Agricultural Parcel Identifying System (<https://www.mepar.hu/mepar/>). © mepar.hu

was observed in 2014 (the first observation since 2003), while additional observations of 1-2 individuals were made in 2015, 2016 and in 2017 (www.piskulka.net accessed on 25/04/2017, HNPd database). During migration, the number of goose flocks reached a maximum of 5,600 individuals in Fishpond V in 2017. Besides LWfG, GWfG, Greylag Geese and Red-breasted geese (*Branta rufficollis*) also used Fishpond V as a resting site. Additionally, formerly disappeared colonies of the rare Whiskered Tern (*Chlidonias hybrida*) and Black-necked Grebe (*Podiceps nigricollis*) were also observed, together with nesting Ferruginous Duck (*Aythya nyroca*).
